MASSACHUSETTS HISTORICAL COMMISSION FORM B - BUILDING

Town Provincetown
Place (neighborhood or village)
Address 4 WEST VINE ST
Building ID 1227
Parcel No. (PID) 06-2-046-0
Mapbase # 06-2-046
Building Area 1525.95
Historic Name
Present Use Residential
Original Use Residential
Date of Construction 1775
Source Tax assessment
Style/Form Italianate
Architect/Builder
Exterior Material wood shingle
Foundation stuccoed
Wall/Trim wood
Roof Irregular
Outbuildings/Secondary Structures

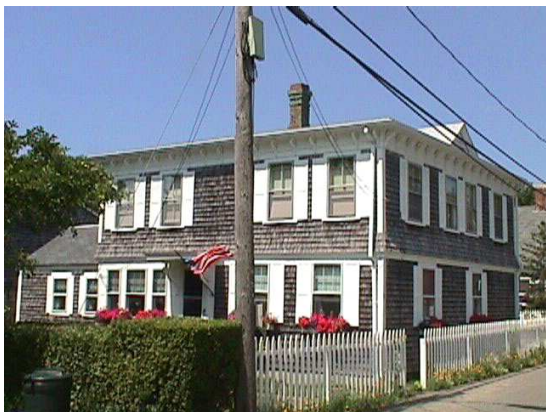
Photograph

4 West Vine Street is a 2-story, 4-bay, 3/4 cottage with hipped roof. Brick chimney centrally located on roof ridge. A small cornice wraps around between 1st and 2nd stories. Main entrance is accessed by a multi-pane-and-panel door with storm door, sheltered by a flat hood supported by elaborate brackets. Fenestration includes grouped 4/1 and 6/1 DHS to left of door, 2 single 6/1 DHS to right of door, 2nd-story windows are 2/2 DHS. Inoperable shutters. Brackets line the main roof eaves. Building faces Commercial Street/water. The rear of the building, with steeply sloping roof, indicates that 2nd story was added to front and east side, likely when Italianate details were added. Entry at 1st floor, and exterior stair to 2nd story entry at east end. 1-story gable roof addition on west end. Separate panel door entry with storm, and 6/1 DHS. 1-story gable-roof extension from rear of this addition has 6/6 DHS window and separate entry.
