MASSACHUSETTS HISTORICAL COMMISSION FORM B - BUILDING

Town Provincetown
Place (*neighborhood or village*)
Address 12 COTTAGE ST
Building ID 138
Parcel No. (PID) 06-4-043-0
Mapbase # 06-4-043
Building Area 1201.491
Historic Name
Present Use Residential
Original Use Residential - Single-unit
Date of Construction 1847
Source Tax assessment
Style/Form Greek Revival
Architect/Builder
Exterior Material wood shingle
Foundation brick
Wall/Trim wood
Roof gable front & ell
Outbuildings/Secondary Structures
 2 secondary structures

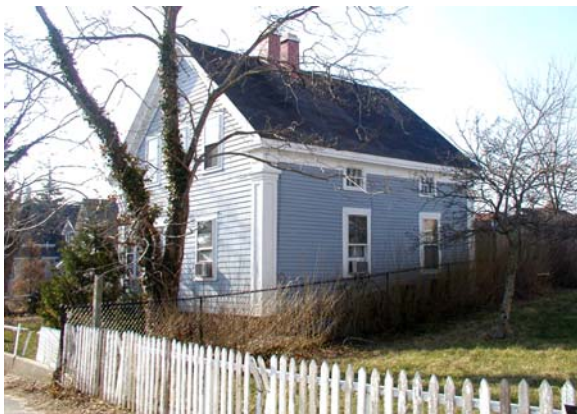
Photograph

This building is a 1 1/2-story, 3-bay cottage with setback ell. Brick chimney on ell roof ridge; new chimneys on main roof slope; partial cornice returns and frieze; corner pilasters. Primary entry, located on the side ell, consists of a modern door and storm. An exterior stair leads to 2nd story entry on south gable end of ell; area under stair screened with lattice. Fenestration includes 2/1 and 6/6 DHS with storms. Main gable front has multi-light picture windows with flanking 2/1 DHS. 2/2 DHS on north facade, and 3/3 DHS just below eaves. Deck along ell.
