MASSACHUSETTS HISTORICAL COMMISSION FORM B - BUILDING

Town Provincetown
Place (neighborhood or village)
Address 6 CONANT ST
Building ID 1567
Parcel No. (PID) 06-4-172-0
Mapbase # 06-4-172
Building Area 830.54
Historic Name
Present Use residential
Original Use Residential
Date of Construction 1840-1860
Source NR Nomination
Style/Form Greek Revival
Architect/Builder
Exterior Material clapboard
Foundation brick
Wall/Trim wood
Roof Side gable
Outbuildings/Secondary Structures
 1 cottage (c. 1960)

Recorded by Johnette Davies
Organization Kise Straw & Kolodner
Date (month/year) April 2004
Form Status new update

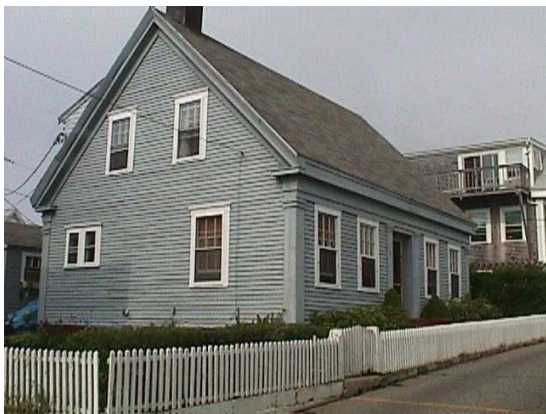
Photograph

This building is a 1-story, 5-bay center entry cottage. The side gable roof has a metal-clad chimney at the ridge and a shed dormer on the rear slope; partial cornice returns. Corner pilasters and frieze frame the primary facade. The main entry is a recessed plank door with diamond-shaped pane; flanking pilasters; concrete stoop with brick side walls. Windows are generally 6/6 DHS except a set of paired 1/1 DHS on the south facade. The wood surrounds for the 6/6 wood DHS windows abut the frieze.
