MASSACHUSETTS HISTORICAL COMMISSION FORM B - BUILDING

Town Provincetown
Place (neighborhood or village)
Address 3 ATLANTIC AVE
Building ID 901
Parcel No. (PID) 07-2-091-0
Mapbase # 07-2-091
Building Area 1161.859
Historic Name
Present Use Residential
Original Use Residential
Date of Construction 1860
Source NR Nomination
Style/Form Greek Revival
Architect/Builder
Exterior Material wood shingle
Foundation brick, concrete block
Wall/Trim wood
Roof cross gable
Outbuildings/Secondary Structures

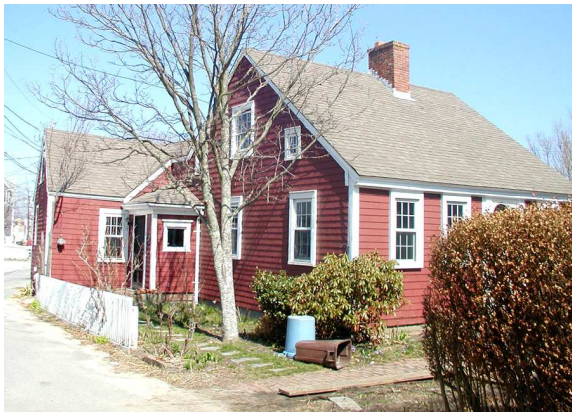
Photograph

3 Atlantic Avenue is a 1 1/2-story, 4-bay 3/4 cottage with side ell and cross gable section in rear. The building faces southward. The side gable roof is clad in asphalt shingles; large interior peak brick chimney. The main entrance consists of a wood panel door with wood surround containing pilasters with fluted tops, historic wood fanlight and denticulated cap. Fenestration includes 6/6 vinyl DHS with surrounds wrapped in vinyl; 6/6 wood window in gable end at attic; 2/2 wood DHS in rear (north) and missing window in upper story of this façade. An enclosed vestibule is located at the corner where the main block and ell meet. This vestibule has a hipped roof with overhanging eave. A secondary entry here consists of a panel door and wood screen. A single-pane wood casement window is adjacent to this door.
