MASSACHUSETTS HISTORICAL COMMISSION FORM B - BUILDING

Town Provincetown
Place (neighborhood or village)
Address 10 CUDWORTH ST
Building ID 40
Parcel No. (PID) 07-4-012-0
Mapbase # 07-4-012
Building Area 1002.191
Historic Name
Present Use Residential
Original Use Residential
Date of Construction 1820
Source Tax assessment
Style/Form Astylistic
Architect/Builder
Exterior Material wood shingle
Foundation stuccoed
Wall/Trim wood
Roof Side gable
Outbuildings/Secondary Structures

Recorded by Johnette Davies
Organization Kise Straw & Kolodner
Date (month/year) April 2004
Form Status new update

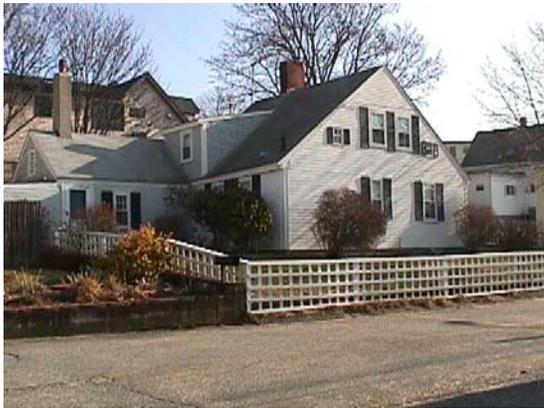
Photograph

Rear ell; replacement windows; dormer

Condition Good
Moved no yes **Date**
Acreage 0.114
Setting

10 Cudworth Street is a 1 1/2-story, 3-bay dwelling with rear ell. The side gable roof has a centered brick chimney at the ridge; shed dormer on rear of main roof abuts the roof of the rear ell. Primary entry (facing west) has panel door with storm and 2-light transom. Secondary entrance on north façade of rear ell. Fenestration includes 6/6 false divided replacement vinyl windows with inoperable louvered shutters; north gable end also has 2 small wood 2/2 DHS; 6/6 DHS window on rear ell, north facade. 1-story rear ell with gable roof and stuccoed chimney. 1-story shed roof section on rear of ell.
