MASSACHUSETTS HISTORICAL COMMISSION FORM B - BUILDING

Town Provincetown
Place (neighborhood or village)
Address 16 ALDEN ST
Building ID 324
Parcel No. (PID) 12-1-030-0
Mapbase # 12-1-030
Building Area 995.956
Historic Name
Present Use Residential - Multi-unit
Original Use Residential
Date of Construction 1850-1870
Source NR Nomination
Style/Form Astylistic
Architect/Builder
Exterior Material wood shingle
Foundation obscured
Wall/Trim wood
Roof Side gable
Outbuildings/Secondary Structures
 1-story shed

Recorded by Johnette Davies
Organization Kise Straw & Kolodner
Date (month/year) April 2004
Form Status new update

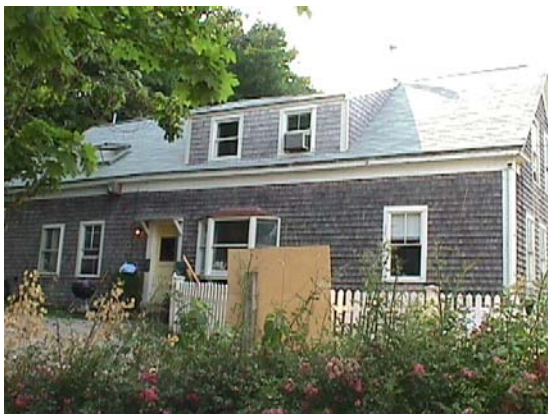
Photograph

replacement door; skylight; entry, sash & siding (20th cent.)

16 Alden Street is a 1 1/2-story, 5-bay building - the primary façade faces south. Side gable roof has partial cornice returns; box cornice, frieze below eaves; shed dormer in south roof slope; skylight; larger shed dormer on north roof slope. Main entry contains a replacement door with simple shed hood above. Windows are 2/1 DHS. Window to right of door is a bay with copper hipped roof and 1/1 DHS. An exterior wood stair and 2nd-story deck and entrance are located at the rear.
