MASSACHUSETTS HISTORICAL COMMISSION FORM B - BUILDING

Town Provincetown
Place (neighborhood or village)
Address 20 ALDEN ST
Building ID 510
Parcel No. (PID) 12-1-032-0
Mapbase # 12-1-032
Building Area 1262.821
Historic Name
Present Use Residential - Multi-unit
Original Use Residential
Date of Construction 1850
Source Tax assessment
Style/Form Greek Revival, Vernacular
Architect/Builder
Exterior Material wood shingle
Foundation stuccoed
Wall/Trim wood
Roof Front gable
Outbuildings/Secondary Structures
 1 shed

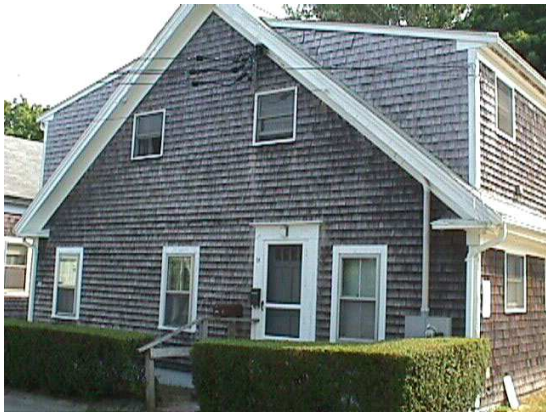
Photograph

replacement windows; addition; shed dormers (mid-20th cent.).

Condition Good
Moved no yes **Date**
Acreage 0.224
Setting

20 Alden Street is a 2-story, 4-bay 3/4 cottage. front-gable roof has partial returns and large shed dormers on each slope creating a full second story. The main entry contains a 4-pane and panel door with storm; simple entablature and wood surround; brick stoop. A secondary entrance is located on the southern facade. Fenestration includes 2/2, 4/4 and 1/1 DHS. 1-story addition is located at the rear. Exterior steps lead to a 2nd-story entry at the rear, above the addition.
