MASSACHUSETTS HISTORICAL COMMISSION FORM B - BUILDING

Town Provincetown
Place (neighborhood or village)
Address 30 ALDEN ST
Building ID 954
Parcel No. (PID) 12-1-035-0
Mapbase # 12-1-035
Building Area 1285.454
Historic Name
Present Use Residential
Original Use Residential
Date of Construction 1850
Source Tax assessment
Style/Form Astylistic
Architect/Builder
Exterior Material wood shingle
Foundation brick
Wall/Trim wood
Roof Front gable
Outbuildings/Secondary Structures
 1 2-story double cottage

Recorded by Johnette Davies
Organization Kise Straw & Kolodner
Date (month/year) April 2004
Form Status new update

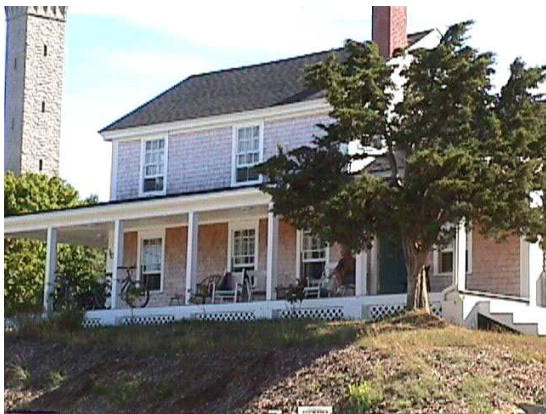
Photograph

This is a 2-story, 3-bay sidehall dwelling oriented toward the south. The front-gable roof has partial returns, brick chimney in east roof slope. The main entry contains a pane and panel door with simple surround. Windows are 6/6 DHS - some wood, some vinyl replacement. 2nd-story windows are directly below the eaves. A 1-story addition is located at the rear (north). An open porch with square posts wraps around the front and east facades, including the addition. A secondary entrance is located on the east façade of the addition.
