MASSACHUSETTS HISTORICAL COMMISSION FORM B - BUILDING

Town Provincetown
Place (neighborhood or village)
Address 5 JOHNSON ST
Building ID 1433
Parcel No. (PID) 12-1-112-0
Mapbase # 12-1-112
Building Area 927.738
Historic Name
Present Use residential
Original Use Residential
Date of Construction 1875
Source Tax assessment
Style/Form Astylistic
Architect/Builder
Exterior Material vinyl
Foundation brick
Wall/Trim vinyl
Roof Cross gable
Outbuildings/Secondary Structures

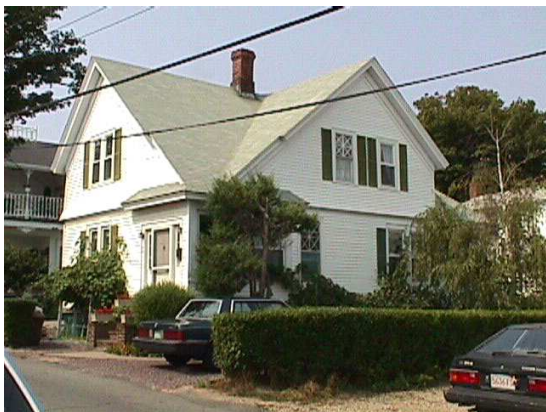
Photograph

5 Johnson Street is a 2-story, 2-bay dwelling. The cross gable roof is clad in asphalt shingles; brick chimney at roof ridge; partial returns. The wall of the second story flares out over the first story. A large cross-gable wall dormer is located on the south façade - this interrupts the cornice and flares out between the first and second stories. The primary entrance includes an aluminum panel door offset to the right with vinyl 3-pane sidelights and modern storm. Fenestration includes 1/1 vinyl DHS; triangular multi-pane-over-one wood DHS (Queen Anne); narrow paired 1/1 vinyl DHS adjacent to the door; inoperable shutters; paired single-pane vinyl casements in the basement.
