MASSACHUSETTS HISTORICAL COMMISSION FORM B - BUILDING

Town Provincetown
Place (neighborhood or village)
Address 4 CENTER ST
Building ID 1200
Parcel No. (PID) 12-1-129-0
Mapbase # 12-1-129
Building Area 1254.566
Historic Name former Methodist Parsonage
Present Use Residential
Original Use Residential
Date of Construction 1870
Source Tax assessment
Style/Form Second Empire
Architect/Builder
Exterior Material clapboard
Foundation brick
Wall/Trim wood
Roof mansard
Outbuildings/Secondary Structures

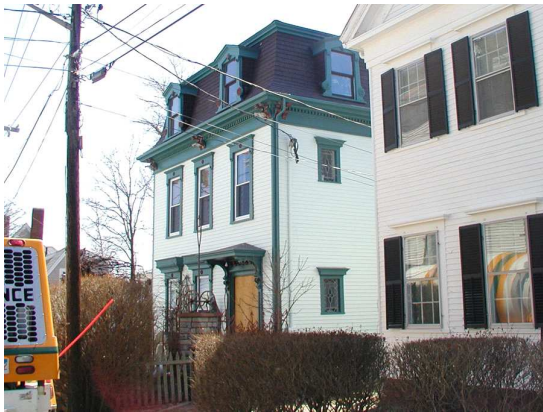
Photograph

This is a 2-story, 3-bay sidehall dwelling, formerly the Methodist parsonage. The mansard roof has gable dormers. Unique trim is the same or similar on all elements - includes dentiled cornice with wide frieze and paired brackets. The main entry is closed up; it is shaded by a flat hood with end brackets. Any secondary entrance is not visible from the street. Windows are replacement 1/1 DHS. Large entablatures over 1st story windows, and smaller entablatures over 2nd story windows. 2-story rear ell.
