MASSACHUSETTS HISTORICAL COMMISSION FORM B - BUILDING

Town Provincetown
Place (neighborhood or village)
Address 41 COMMERCIAL ST
Building ID 1255
Parcel No. (PID) 05-4-008-0
Mapbase # 05-4-008
Building Area 2258.77
Historic Name Masthead Motel
Present Use Commercial - Lodging
Original Use Commercial
Date of Construction 1850
Source Tax assessment
Style/Form Greek Revival
Architect/Builder
Exterior Material Wood shingle
Foundation brick
Wall/Trim wood
Roof Front Gable
Outbuildings/Secondary Structures
 hotel complex contains 4 cottages

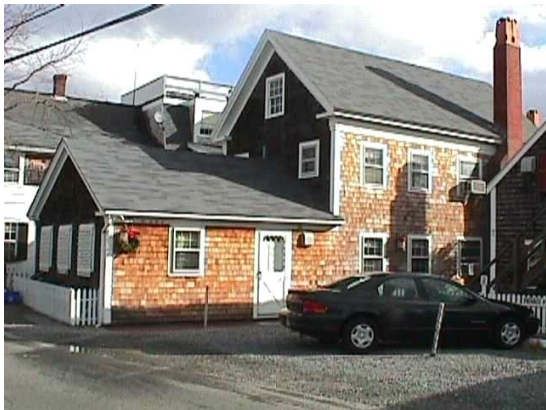
Photograph

41 Commercial St. is a 2-1/2-story, 4-bay side-gable core with 1-story 2-bay front addition and a hyphen connecting a 1-story rear addition; The roof is clad in asphalt shingles and includes a wood cornice and partial returns; a sidewall brick chimneys with terra cotta cap is located on the north façade; a second brick chimney is located on the rear addition. The exterior is clad in wood shingles with simple wood cornerboards; Fenestration includes 6/6 DHS wood windows with simple wood surrounds and wood lattice-work over street-facing windows; the rear façade contains a projecting 2nd story addition.
