MASSACHUSETTS HISTORICAL COMMISSION FORM B - BUILDING

Town Provincetown
Place (neighborhood or village)
Address 36 COMMERCIAL ST
Building ID 1118
Parcel No. (PID) 05-4-016-0
Mapbase # 05-4-016
Building Area 1854.149
Historic Name
Present Use Residential
Original Use Residential
Date of Construction 1840
Source Tax assessment
Style/Form Greek Revival
Architect/Builder
Exterior Material Clapboard
Foundation obscured
Wall/Trim wood
Roof Front Gable
Outbuildings/Secondary Structures

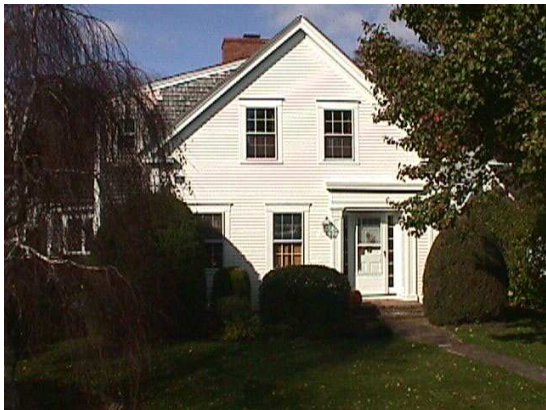
Side additions; shed dormer; chimney rebuilt

This is a 2 story; 3-bay building with an irregular plan, clad in clapboard on the primary façade and wood shingles on secondary façades. The front-gable roof with wood box cornice with partial returns features a large central brick chimney at the roof ridge. Two gable dormers containing 6/6 DHS are located on the eastern roof slope. A brick path leads to a brick landing at the primary entry. This entry has a 4-panel door with 4 panes across the top and a storm door, and the surround includes sidelights, pilasters and heavy entablature. Fenestration is primarily 6/6 DHS, with 1/1 and 2/2 DHS located on secondary façades. A canted bay is located on west façade; a 1-story shed roof addition is located near the rear of the west façade. A deck is located above this addition. The rear façade features a 2-bay garage with 16-panel overhead doors. Exterior wood steps lead to a 2nd-story entry and deck on south façade, which extends over an enclosed 1st story. A central entrance here has a panel door flanked by windows.

Brick retaining wall along front property edge, Front picket gable has tiles embedded in top of gate piers;
