MASSACHUSETTS HISTORICAL COMMISSION FORM B - BUILDING

Town Provincetown
Place *(neighborhood or village)*
Address 58 COMMERCIAL ST
Building ID 1518
Parcel No. (PID) 06-2-031-0
Mapbase # 06-2-031
Building Area 1131.529
Historic Name
Present Use Residential
Original Use Residential
Date of Construction 1830
Source NR Nomination
Style/Form Greek Revival
Architect/Builder
Exterior Material Wood shingle
Foundation brick
Wall/Trim wood
Roof Front Gable
Outbuildings/Secondary Structures
 Modern shed

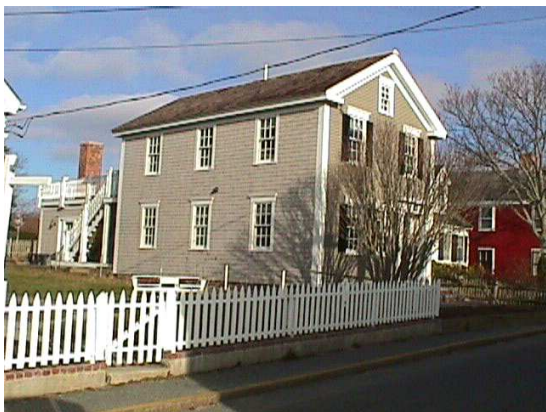
Photograph

58 Commercial St is a 2-story, 3-bay sidehall dwelling with a front-gable roof and wood shingle cladding. The wood box cornice has partial returns; corner boards frame the facades. The recessed primary entry door is 2 vertical panels with 5-light sidelights; the wood door surround has an entablature and pilasters. Fenestration is primarily 6/6 wood DHS replacement windows with inoperable louvered shutters, though some operable shutters do exist on the building (side façades). There is a 4/4 DHS window in gable end. The eastern façade is 5 bays with a panel central entry door, 4-light transom, entablature and pilasters. The 1-story rear addition has a multi-light entry door with glass storm and small entablature. Exterior steps with turned balustrade lead to a roof deck. There is a secondary entrance with multi-light door and sidelights. A brick chimney is located at the end of this ell.
