MASSACHUSETTS HISTORICAL COMMISSION FORM B - BUILDING

Town Provincetown
Place (neighborhood or village)
Address 12 BRADFORD ST
Building ID 129
Parcel No. (PID) 06-4-072-0
Mapbase # 06-4-072
Building Area 1259.657
Historic Name
Present Use Residential - Multi-unit
Original Use Residential
Date of Construction 1890
Source Tax assessment
Style/Form Colonial Revival
Architect/Builder
Exterior Material wood shingle
Foundation brick
Wall/Trim wood
Roof Cross gable
Outbuildings/Secondary Structures
 1 garage

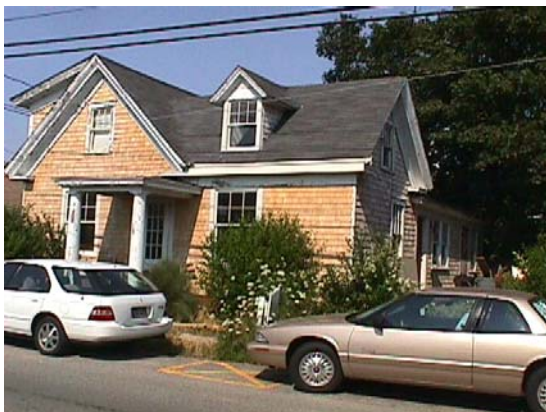
This is a 1 1/2-story, sidehall cottage with an ell. The gable end has partial returns, and there is a frieze below the eaves of the ell. The ell also extends to the rear of the building. A large shed dormer was added to the southern roof slope. A gabled dormer is located in the front roof slope of the side ell. Windows are historic and replacement 6/1 DHS, which are typical of the Colonial Revival period. The front entry porch, with a flat roof and Doric columns, is also typical of the period. Recently resided. Porch contains a brick stoop. Multi-pane storm wood door. The right side façade contains 6/1 DHS and 2 secondary entries - one with a wood deck. The left side façade contains 6/1 DHS. The rear façade contains a 1-story addition with entry and 6/1 DHS window.
