MASSACHUSETTS HISTORICAL COMMISSION FORM B - BUILDING

Town Provincetown
Place (neighborhood or village)
Address 34 BRADFORD ST
Building ID 1003
Parcel No. (PID) 06-4-167-0
Mapbase # 06-4-167
Building Area 903.582
Historic Name
Present Use Residential
Original Use Residential
Date of Construction 1880
Source Tax assessment
Style/Form Dutch Colonial Revival
Architect/Builder
Exterior Material wood shingle
Foundation brick
Wall/Trim wood
Roof front gambrel
Outbuildings/Secondary Structures

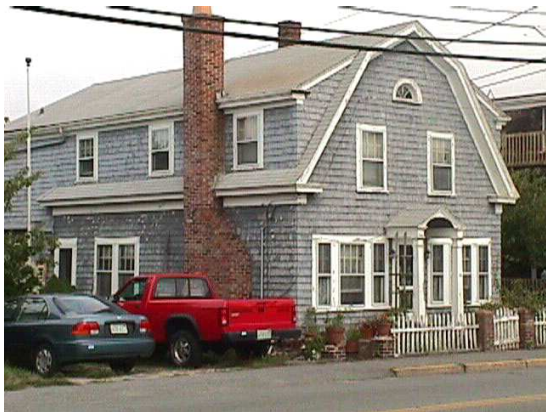
Photograph

34 Bradford Street is a 2-story, 3-bay dwelling with a central entry. The entry has a broken pediment hood, supported by battered square posts. Windows flanking the front door are grouped 6/1 DHS flanked by 4/1 DHS wood with storms. Other windows are 6/1 DHS. There is a fanlight in the top of the gable end. The roof has partial cornice returns, and there are shed dormers on each roof slope. An exterior brick chimney extends upward through the main roof and shed dormer eaves. The porch contains a brick stoop. The right side façade facing Montello Street contains paired and single 6/1 DHS. The left side façade contains paired and single 6/1 DHS with wood surrounds, an exterior brick chimney, secondary entrance with storm door and paired 4-light casements. Also on this façade, the shed dormer extends to become main roofline for rear 2-story section. The rear façade contains a 2-story addition has concrete block foundation, a slightly flared eave and has grouped 8-light and 6-light casements.
