MASSACHUSETTS HISTORICAL COMMISSION FORM B - BUILDING

Town Provincetown
Place (neighborhood or village)
Address 70 BRADFORD ST
Building ID 1757
Parcel No. (PID) 07-2-177-0
Mapbase # 07-2-177
Building Area 1664.972
Historic Name
Present Use Commercial - Lodging
Original Use Residential
Date of Construction 1850
Source Tax assessment
Style/Form Greek Revival
Architect/Builder
Exterior Material clapboard
Foundation brick
Wall/Trim wood
Roof Front gable
Outbuildings/Secondary Structures

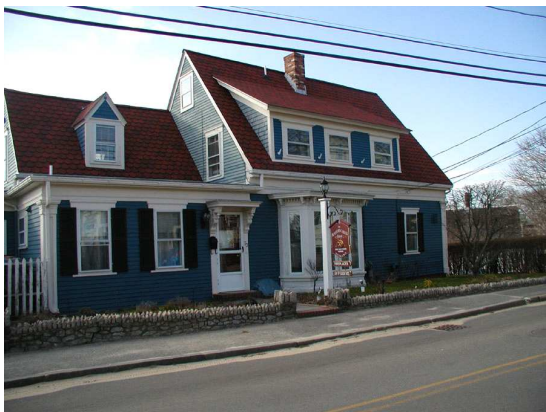
Photograph

Currently "the Bradford-Carver House"; 70 Bradford Street is a 1 1/2-story, 3-bay sidehall building. The primary façade faces Carver Street. Later alterations have reoriented the building to face Bradford Street. The primary (Carver Street) façade has a sidehall entrance, and the recessed door is flanked by pilasters and capped by a heavy entablature. The windows have wood surrounds and operable shutters. The window trim is reflected in original window locations on the Bradford Street façade. Corner pilasters are also present. The Bradford Street façade has a frieze below the eaves. A shed-roofed dormer was added to this roof slope, and a square bay window was added to the façade during late 19th-century alterations. An addition has been added to the rear of the building (the side of this façade), and this accommodates a secondary entry. This entry is protected by a flat-roofed hood supported by brackets. A gabled dormer is present on the side gable roof slope of this addition. A brick chimney is located at the main roof ridge of the building. A gable dormer and skylight are located on the north roof slope. Roof is clad in octagonal-shaped asphalt shingles. A 1-story square addition with a wood 6/6 DHS window is located on the north façade.
