# MASSACHUSETTS HISTORICAL COMMISSION FORM B - BUILDING

**Town** Provincetown  
**Place** (neighborhood or village)  
**Address** 87 BRADFORD ST  
**Building ID** 1861  
**Parcel No. (PID)** 11-3-059-0  
**Mapbase #** 11-3-059  
**Building Area** 659.371  
**Historic Name**  
**Present Use**  
**Original Use** Residential  
**Date of Construction** 1820-1850  
**Source** NR Nomination  
**Style/Form** Astylistic  
**Architect/Builder**  
**Exterior Material** wood shingle  
**Foundation**  
**Wall/Trim**  
**Roof** Front gable  
**Outbuildings/Secondary Structures**

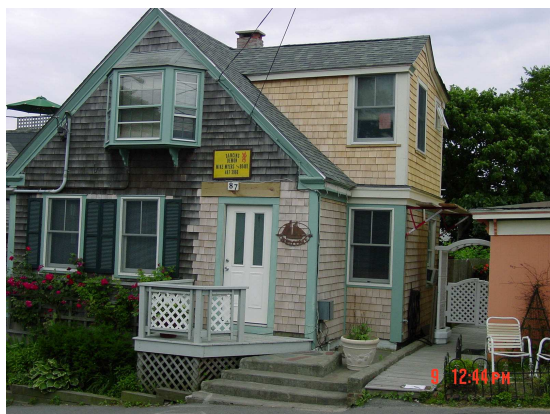
87 Bradford Street is a 1-story, 3-bay sidehall cottage with a 2-story addition at the side, which extends into the main roofline. The primary façade has partial cornice returns and corner boards. The primary façade has a replacement door and 2/2 DHS windows on the 1st floor, and a canted bay window supported by knee braces in the gable end. Windows in this bay are 8/8 and 4/4 DHS. There are shutters present at the 1st story. The door is reached by concrete steps and a wood deck. The 2-story addition, located on the southwest side of the building, forms a cross gable with the main roof. Cornices and corner boards are present; windows are 2/2 DHS. The windows on the side gable façade (facing Bradford Street) are located directly below the eaves.
