MASSACHUSETTS HISTORICAL COMMISSION FORM B - BUILDING

Town Provincetown
Place (neighborhood or village)
Address 368 COMMERCIAL ST
Building ID 1129
Parcel No. (PID) 12-1-113-0
Mapbase # 12-1-113
Building Area 2856.664
Historic Name Johnson/Matheseon House
Present Use Commercial - Lodging
Original Use Commercial - Lodging
Date of Construction 1800-1840
Source Tax assessment
Style/Form Greek Revival, Vernacular
Architect/Builder
Exterior Material Wood shingle
Foundation brick
Wall/Trim wood
Roof Front gable
Outbuildings/Secondary Structures

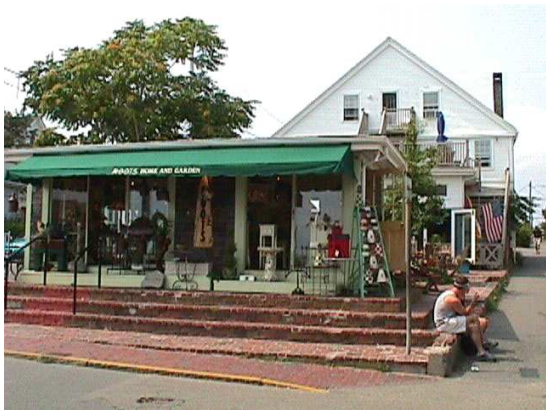
Also has an address of 3 Johnson Street; 368 Commercial St. is a 2-1/2-story, 5-bay, vernacular Greek Revival-style commercial lodging building with multiple retail additions; gable-front roof is sheathed in asphalt shingles, full cornice return, brick chimney; exterior is clad in wood shingles with wood trim; building sits on a brick foundation; fenestration includes 6/6 DHS; 1-story commercial addition has sliding glass doors on each façade, retractable cloth awnings, brick steps, L-shaped plan; 1-story addition attached to main building and currently called "Mona's Antiques" contains paired double doors with awning windows above, exterior staircase to deck and 3rd-story entry facing south; main building faces (south) Commercial Street and contains 6/6 replacement DHS; side of building facing Arch Street contains 6/6 replacement wood DHS with storms and wood shingle siding; north side of main building contains 6/6 DHS, 1- and 2-light awnings and full cornice return; rear 1-story ell has secondary entry, 6/6 DHS and wood shingle siding; side of main building façade facing Johnson Street is 2-story, 2-bay with side-gable roof, has a large door surround with fluted pilasters, denticulated cornice, 3-light sidelights, 6-panel door, multi-pane bay window with flanking 4/4 DHS, 6/6 wood DHS and deck, a side addition toward Bradford Street with 5-bays, entry doors, 2 canted bay windows, 2 shed dormers with 6/6 DHS, and octagonal windows.
