MASSACHUSETTS HISTORICAL COMMISSION FORM B - BUILDING

Town Provincetown
Place *(neighborhood or village)*
Address 448 COMMERCIAL ST
Building ID 1328
Parcel No. (PID) 12-4-041-0
Mapbase # 12-4-041
Building Area 1861.473
Historic Name
Present Use Commercial - Lodging
Original Use Residential
Date of Construction 1850
Source Tax assessment
Style/Form Greek Revival
Architect/Builder
Exterior Material Clapboard
Foundation brick
Wall/Trim wood
Roof Front Gable
Outbuildings/Secondary Structures
 Attached 1-story gable-roof shed

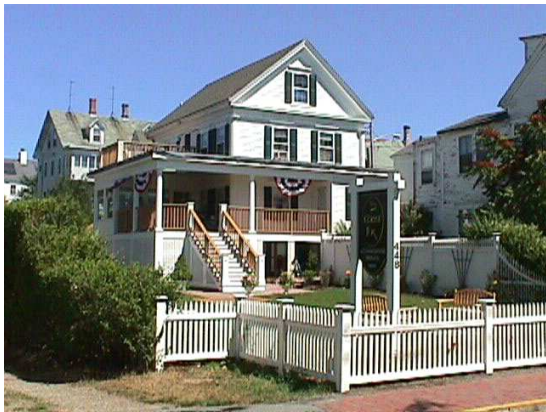
Photograph

Verandah; 2nd floor deck; rear decks and exterior stairs.

Condition Good
Moved no yes **Date**
Acreage 0.321
Setting

448 Commercial St. is a 2-1/2 story, Greek Revival-style dwelling converted to commercial lodging use; gable-front roof is sheathed in asphalt shingles, full cornice return; exterior is clad in clapboard siding with wood corner boards and trim; building sits on a raised brick foundation; fenestration includes 6/6 DHS replacement windows, modillioned lintels and retractable awnings on left side façade, inoperable panel shutters; wrap-around verandah with Doric columns and new balustrade, porch has lattice skirting; 2nd-floor deck on side façade; modillioned cornices and trim throughout; secondary entries at raised basement level; exterior steps to 3rd-story entrance; engaged fluted columns; large gable dormer with partial cornice returns; brick ridge chimney on ell; rear decks; front yard is enclosed by a wood picket fence.
