MASSACHUSETTS HISTORICAL COMMISSION FORM B - BUILDING

Town Provincetown
Place (neighborhood or village)
Address 169 BRADFORD ST
Building ID 368
Parcel No. (PID) 12-4-080-0
Mapbase # 12-4-080
Building Area 967.578
Historic Name
Present Use Residential
Original Use Residential
Date of Construction 1850>
Source NR Nomination
Style/Form Italianate, Vernacular
Architect/Builder
Exterior Material asbestos siding
Foundation brick
Wall/Trim aluminum
Roof Side gable
Outbuildings/Secondary Structures

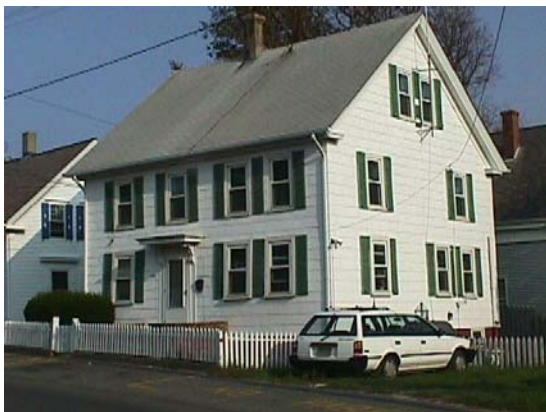
Entry details added c. 1890; replacement windows, 1980s.

Condition Good
Moved no yes **Date**
Acreage 0.076
Setting

169 Bradford Street is a 2-story, 4-bay, Vernacular Italianate-style 3/4 dwelling; the roof is side gable with a central brick chimney covered with stucco, partial cornice returns and aluminum boxed eave; The exterior is clad in asbestos siding and the foundation is brick; The windows are 1/1 vinyl DHS and have inoperable shutters; The primary entrance contains a modern aluminum panel door with an aluminum covered flat-roof hood supported by brackets and accessed by a concrete block and brick porch deck; There is a picket fence around the front of the property
