MASSACHUSETTS HISTORICAL COMMISSION FORM B - BUILDING

Town Provincetown
Place (neighborhood or village)
Address 178 BRADFORD ST
Building ID 413
Parcel No. (PID) 12-4-108-0
Mapbase # 12-4-108
Building Area 2265.857
Historic Name
Present Use Commercial - Lodging
Original Use Residential
Date of Construction 1820
Source Tax assessment
Style/Form Astylistic
Architect/Builder
Exterior Material wood shingle
Foundation brick
Wall/Trim wood
Roof Cross gable
Outbuildings/Secondary Structures

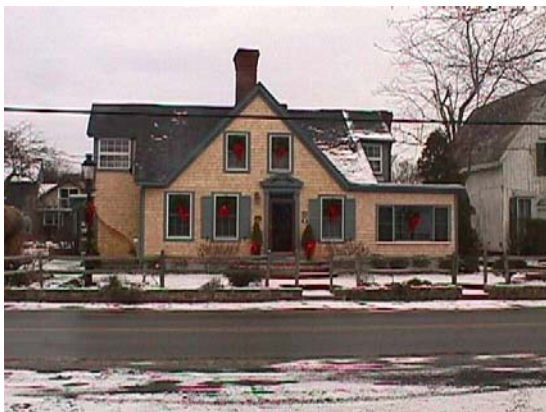
178 Bradford Street is a 1 1/2-story, 4-bay, Astylistic building; the roof is cross gable, a large corbelled brick chimney rises from the center of the roof ridge and an additional corbelled brick chimney is located at the rear; the exterior is clad in wood shingles with wood trim; the fenestration includes replacement 6/6 DHS, some operable shutters on the front façade; the primary entrance has a replacement door with transom and wood surround capped by a decorated broken pediment; an addition on the side of the primary façade has a picture window; additions to the rear and side are 1 and 2 stories in height, with 2/2, 8/8, and 6/6 DHS, and secondary entrances on each side.
