MASSACHUSETTS HISTORICAL COMMISSION FORM B - BUILDING

Town Provincetown
Place (neighborhood or village)
Address 242 BRADFORD ST
Building ID 696
Parcel No. (PID) 15-2-028-0
Mapbase # 15-2-028
Building Area 893.48
Historic Name
Present Use Residential
Original Use Residential
Date of Construction 1800
Source Tax assessment
Style/Form Greek Revival
Architect/Builder
Exterior Material clapboard
Foundation
Wall/Trim
Roof Side gable
Outbuildings/Secondary Structures

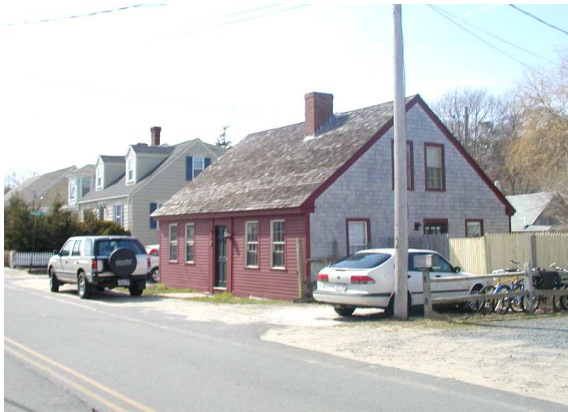
Cornice rebuilt; replacement windows; chimney rebuilt

242 Bradford Street is a 1 1/2-story, 5-bay, Greek Revival cottage; the roof is side gable, the box cornice has been rebuilt, and there are small partial cornice returns on the gable ends, a central brick chimney is located just below the roof ridge on the front roof slope; clapboard clads the primary façade, while wood shingles are on the secondary facades; the fenestration includes 6/6 DHS, 2/2 wood DHS; the primary entrance contains a central wood panel door with simple wood surround, secondary entrances are located on the east and west façades
