# MASSACHUSETTS HISTORICAL COMMISSION FORM B - BUILDING

**Town** Provincetown  
**Place** (neighborhood or village)  
**Address** 636 COMMERCIAL ST  
**Building ID** 1653  
**Parcel No. (PID)** 17-1-014-0  
**Mapbase #** 17-1-014  
**Building Area** 941.469  
**Historic Name**  
**Present Use** Residential-seasonal  
**Original Use** Residential  
**Date of Construction** 1920  
**Source** Tax assessment  
**Style/Form** Craftsman  
**Architect/Builder**  
**Exterior Material** wood shingle  
**Foundation** obscured  
**Wall/Trim** wood  
**Roof** Side gable  
**Outbuildings/Secondary Structures**

**Recorded by** Johnette Davies  
**Organization** Kise Straw & Kolodner  
**Date** (month/year) December 2003  
**Form Status**  new  update

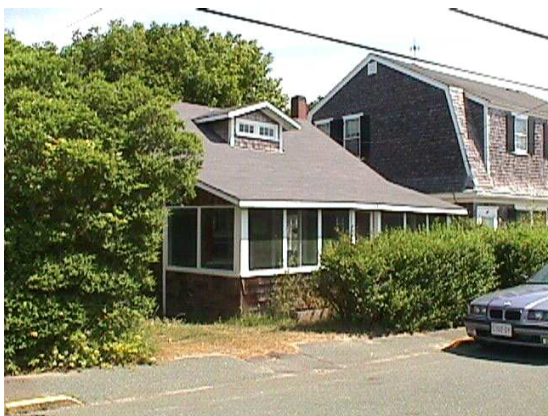
Roll	Negative(s)

636 Commercial Street is a 1-1/2-story bungalow with a gable dormer with paired 3-light awnings. The incised porch is enclosed by a wood shingle-clad half wall. Screens have been recently removed from the porch. A brick chimney is visible at the end of the roof ridge. Windows have operable shutters. The left side façade near the rear contains a 1-story porch enclosure with lattice. The right side façade contains a canted bay with hipped roof. Windows closed for season at time of survey. 1-bay side-gable section facing rear of building on concrete block piers. Deck across back.
