# MASSACHUSETTS HISTORICAL COMMISSION FORM B - BUILDING

**Town** Provincetown  
**Place** (neighborhood or village)  
**Address** 3 NICKERSON ST  
**Building ID** 934  
**Parcel No. (PID)** 06-2-079-0  
**Mapbase #** 06-2-079  
**Building Area** 1380.962  
**Historic Name** Elijah Doane Cottage  
**Present Use** Residential  
**Original Use** Residential  
**Date of Construction** 1800-1830  
**Source** NR Nomination  
**Style/Form** Greek Revival  
**Architect/Builder**  
**Exterior Material** clapboard  
**Foundation** brick  
**Wall/Trim** wood  
**Roof** Side gable  
**Outbuildings/Secondary Structures**  
 historic studio/workshop (NOT ATTACHED)

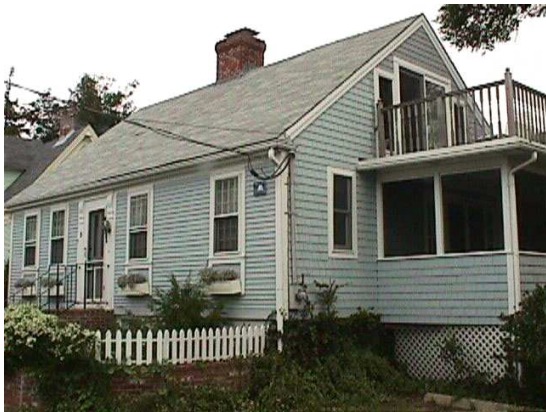
Roll	Negative(s)

1-story, 5-bays; asphalt roof shingles; massive brick interior chimney at peak; clapboard on front façade, wood shingles on secondary facades; raised basement; primary entrance contains pane and panel wood door with wood storm; entrance contains a wood surround flanked by pilasters topped with fluted, bowed capitals; vinyl sliding doors on 2nd floor, paired modern French doors, screened-in 1st floor porch with a rooftop deck and latticework at bottom; fenestration includes 12/12 wood DHS with panels below, applied dentils in window lintels, 1/1 vinyl DHS on south façade, 6-pane wood awning basement windows; 1/1 vinyl DHS on north façade

Connected to the extended 1-story porch of the main house is a 2-story, 2-bay, Astylistic historic workshop/studio that has been converted to a residence; the side gable roof is clad in asphalt shingles; the exterior walls are clad in wood shingles and the foundation is obscured; the primary entrance contains a wood pane and panel door accessed by exterior wood steps and deck;
