MASSACHUSETTS HISTORICAL COMMISSION FORM B - BUILDING

Town Provincetown
Place (neighborhood or village)
Address 6 WINTHROP ST
Building ID 1600
Parcel No. (PID) 07-2-113-0
Mapbase # 07-2-113
Building Area 1417.265
Historic Name Atwood Foss House
Present Use Residential - Multi-unit
Original Use Residential
Date of Construction 1836
Source Sign on building
Style/Form Greek Revival
Architect/Builder
Exterior Material clapboard
Foundation brick
Wall/Trim wood
Roof Front gable
Outbuildings/Secondary Structures

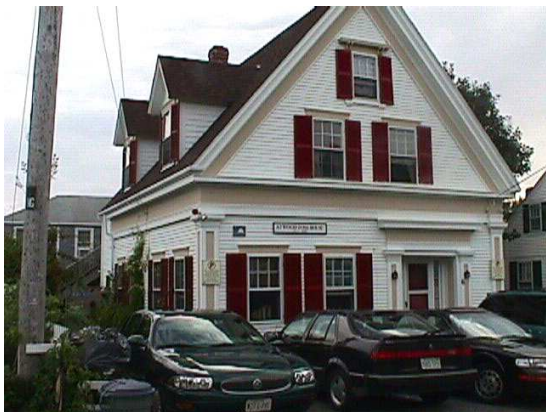
Photograph

6 Winthrop Street is a 1-1/2-story, 3-bay sidehall entry building with a brick chimney at the rear gable end, 2 gabled dormers on the south slope and 1 on the north slope. Main entry is recessed panel door with storm and sidelights. The heavy surround includes pilasters and entablature. The gable end is fully pedimented. Windows are 6/6 wood DHS with wood trim and operable louvered shutters. The gable end window (top) has paired end brackets. Two 2-story rear additions; the rear-most is clad in wood shingles and has exterior steps leading to 2nd story deck and entry. Skylight in 1st rear addition.
