MASSACHUSETTS HISTORICAL COMMISSION FORM B - BUILDING

Town Provincetown
Place (neighborhood or village)
Address 22 WINTHROP ST
Building ID 621
Parcel No. (PID) 07-2-120-0
Mapbase # 07-2-120
Building Area 863.37
Historic Name
Present Use Residential
Original Use Residential
Date of Construction 1950-1970
Source Tax assessment
Style/Form
Architect/Builder
Exterior Material clapboard
Foundation concrete block
Wall/Trim wood
Roof offset center gable
Outbuildings/Secondary Structures

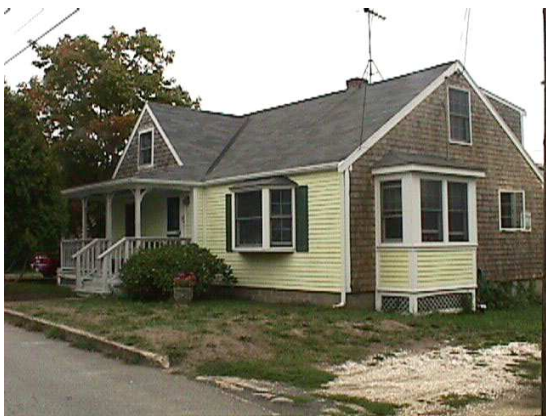
Photograph

22 Winthrop Street is a 1-story, 3-bay cottage. Side-gable roof with brick chimney on rear slope; offset gable on front roof slope. Main entry has pane and-panel door with storm and simple surround. A hipped-roof open porch encompasses the gable portion of front facade. Posts are square with knee braces; turned balustrade. Windows are 6/6, 6/1 false divided DHS with storms. Canted bay window in right portion of front façade has 1/1 central window and 4/4 side windows. 1-story hipped roof square bay on north facade with 6/1 false divided DHS. Shed dormer on rear roof slope.
