MASSACHUSETTS HISTORICAL COMMISSION FORM B - BUILDING

Town Provincetown
Place *(neighborhood or village)*
Address 21 STANDISH ST
Building ID 579
Parcel No. (PID) 12-1-072-0
Mapbase # 12-1-072
Building Area 1112.689
Historic Name
Present Use Residential
Original Use Residential
Date of Construction 1800-1830
Source NR Nomination
Style/Form Astylistic
Architect/Builder
Exterior Material wood shingle
Foundation brick
Wall/Trim wood
Roof side gable
Outbuildings/Secondary Structures

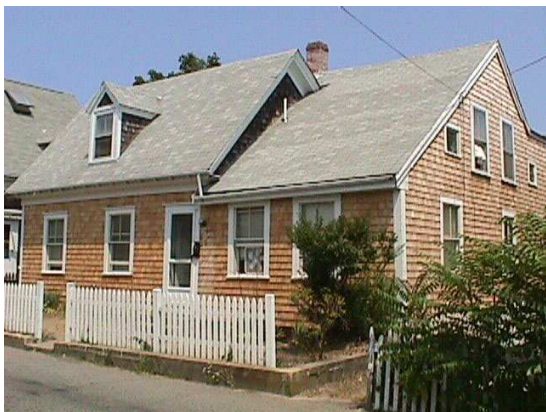
Photograph

1 1/2-story, 5-bay; 2-bays to the right (south) have lower roof line; Halifax roofline in rear that connects with flat roof; asphalt roof shingles; partial cornice returns, corner boards and fascia; 2 wall dormers; 2/1 vinyl DHS with wood surrounds; main center entry has pane and panel aluminum door with modern storm, wood surround with flat shallow lintel and concrete steps; secondary entrance on south side near east (rear); exterior stair to 2nd floor entrance in east side; 2-story rear section;

Original is probably 3-bay cottage on right.
