MASSACHUSETTS HISTORICAL COMMISSION FORM B - BUILDING

Town Provincetown
Place (neighborhood or village)
Address 19 COMMERCIAL ST
Building ID 462
Parcel No. (PID) 05-3-004-0
Mapbase # 05-3-004
Building Area 1052.571
Historic Name
Present Use Residential
Original Use Residential
Date of Construction 1920
Source NR Nomination
Style/Form Colonial Revival
Architect/Builder
Exterior Material Wood shingle
Foundation covered with planks
Wall/Trim wood
Roof Pyramidal
Outbuildings/Secondary Structures

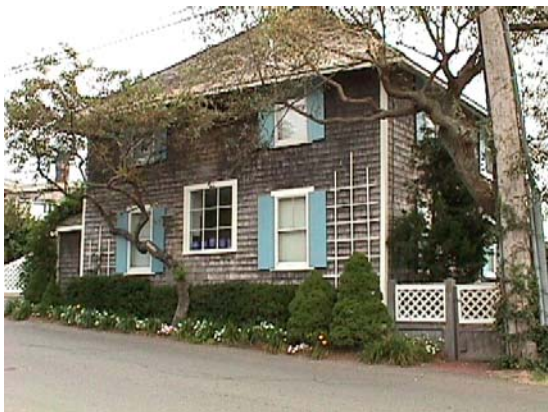
Photograph

19 Commercial St is a 2-story, 3-bay building clad in wood shingles with a pyramidal roof. Fenestration includes 2/1 double-hung wood sash windows with wood sills and inoperable shutters; and a 9-pane fixed window. The primary entrance includes an enclosed vestibule with a wood pane and panel door. The wood shingle roof has a wide overhanging eave with exposed rafter tails. The rear façade has an open porch.
