**MASSACHUSETTS HISTORICAL COMMISSION
FORM B - BUILDING**

Town Provincetown
Place *(neighborhood or village)*
Address 9-11 COMMERCIAL ST
Building ID 1924
Parcel No. (PID) 05-3-006-0
Mapbase # 05-3-006
Building Area 2107.45
Historic Name
Present Use Residential
Original Use Residential
Date of Construction 1880
Source Tax assessment
Style/Form Colonial Revival
Architect/Builder
Exterior Material Wood shingle
Foundation concrete block under enclosed porch
Wall/Trim wood
Roof Front Gable
Outbuildings/Secondary Structures
 Secondary structure appended to the front/side

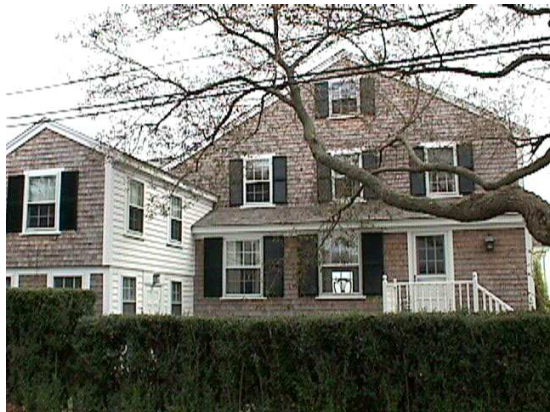
Photograph

Side addition, c. 1970s; enclosed porch.

Condition Good
Moved no yes **Date**
Acreage 0.42
Setting

Address in field is 11 Commercial Street; This is a 2-1/2 story, 3 bay front-gable building. The exterior is clad in wood shingles. Window openings contain six-over-six double hung wood sash with operable louvered shutters. The basement has 4-pane wood awning windows. The enclosed front porch has a concrete block foundation and eight-over-eight double hung wood sash windows. The front entrance contains a multi-light wood replacement door that is accessed by modern steps and deck. A projecting 2-story addition clad in wood shingles and wood clapboard contains 6/6 DHS and a modern paneled door.
