MASSACHUSETTS HISTORICAL COMMISSION FORM B - BUILDING

Town Provincetown
Place (neighborhood or village)
Address 18 BRADFORD ST
Building ID 419
Parcel No. (PID) 06-4-098-0
Mapbase # 06-4-098
Building Area 1181.355
Historic Name
Present Use Residential - Multi-unit
Original Use Residential
Date of Construction 1880
Source Tax assessment
Style/Form Astylistic
Architect/Builder
Exterior Material wood shingle
Foundation brick
Wall/Trim wood
Roof Side gable
Outbuildings/Secondary Structures

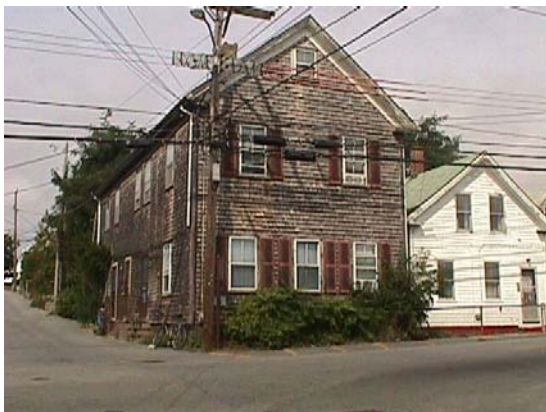
Photograph

This is a 2-story building with its gable end facing Bradford Street and its front facade facing Franklin Street. The gable end has 3 bays, and the front facade has 5 bays. Windows are 2/2 wood replacement DHS. Fenestration has been altered on the front facade to allow for multiple entry doors for residential use. Poured concrete steps lead to these entries. Building also contains partial corner returns and corner boards. The right side facade contains only 2nd-story 2/2 DHS windows in front portion. The left side facade has three entries with concrete stoops, modern doors and storms and 2/2 replacement DHS with storms and wood trim surrounds. The rear facade contains entries at 1st and 2nd levels, a 2nd story deck.
