MASSACHUSETTS HISTORICAL COMMISSION FORM B - BUILDING

Town Provincetown
Place (neighborhood or village)
Address 230 COMMERCIAL ST
Building ID 658
Parcel No. (PID) 11-3-044-0
Mapbase # 11-3-044
Building Area 2890.335
Historic Name Benjamin Lancy House
Present Use Commercial
Original Use Residential
Date of Construction 1874
Source NR Nomination
Style/Form Second Empire
Architect/Builder
Exterior Material Clapboard
Foundation rusticated stone
Wall/Trim wood
Roof Mansard
Outbuildings/Secondary Structures

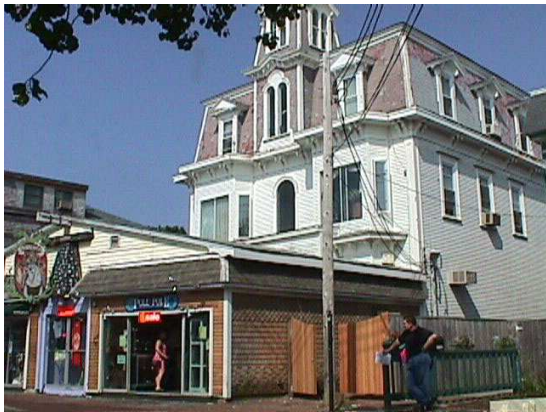
Photograph

230 Commercial St. is a 3-story, 3-bay, Second Empire-style dwelling converted to commercial use; mansard roof is sheathed in asphalt shingles, pedimented and gable dormers with brackets and pendants, cornice with paired brackets and pendants; exterior is clad in clapboard siding with wood corner boards and trim, east façade is clad in shaped wood shingles; building sits on an obscured foundation; fenestration includes 1/1 vinyl DHS, 2nd-story canted bays with single-pane sliding glass windows; mansard roof has a projecting central pavilion with tower; modern 1-story gable-front commercial addition with pent eave extends from the front façade, obscuring the original main entrance; primary entrance now located in addition's center bay and is accessed by modern paired large-light doors flanked by sliding glass doors accessing separate businesses; west façade may contain an entrance to historic core.
