MASSACHUSETTS HISTORICAL COMMISSION FORM B - BUILDING

Town Provincetown
Place (neighborhood or village)
Address 109 BRADFORD ST
Building ID 74
Parcel No. (PID) 11-3-082-0
Mapbase # 11-3-082
Building Area 864.496
Historic Name
Present Use Residential
Original Use Residential
Date of Construction 1840
Source NR Nomination
Style/Form Federal
Architect/Builder
Exterior Material clapboard
Foundation obscured
Wall/Trim wood
Roof saltbox
Outbuildings/Secondary Structures

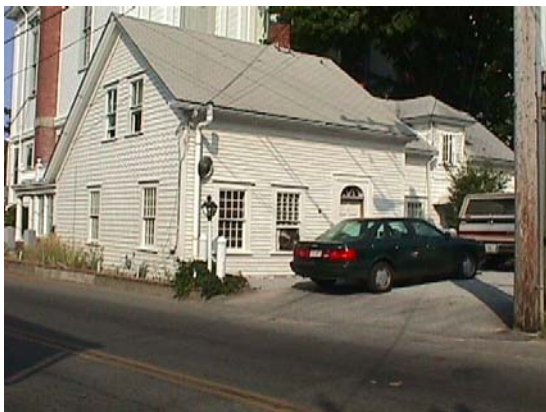
Photograph

109 Bradford Street is a 1-story, 3-bay, Federal-style dwelling; the saltbox roof is clad in asphalt shingles, there are two interior brick chimneys, and the roof slope is interrupted by hipped wall dormers on both facades; the exterior is clad in clapboard on the west façade and wood shingles on the north façade; the fenestration includes 12/12 wood DHS and triple 6-pane wood casements and 6/6 vinyl DHS on the hipped wall dormers; The primary entrance contains a historic wood panel door, wood surround and historic fanlight with an "M"; A 1-story, 3-bay saltbox section is connected to the south side has a wood shingle covered front (east) façade, central entry with wood panel door, gable hood supported by square wood brackets and truss-like gable design
