MASSACHUSETTS HISTORICAL COMMISSION FORM B - BUILDING

Town Provincetown
Place (neighborhood or village)
Address 274-276 COMMERCIAL ST
Building ID 820
Parcel No. (PID) 11-3-095-0
Mapbase # 11-3-095
Building Area 2506.065
Historic Name
Present Use Commercial/Residential - Multi-unit
Original Use Commercial
Date of Construction 1892
Source Jennings
Style/Form Queen Anne
Architect/Builder
Exterior Material Clapboard
Foundation brick
Wall/Trim wood
Roof Front Gable
Outbuildings/Secondary Structures

Recorded by Johnette Davies
Organization Kise Straw & Kolodner
Date (month/year) September 2003
Form Status new update

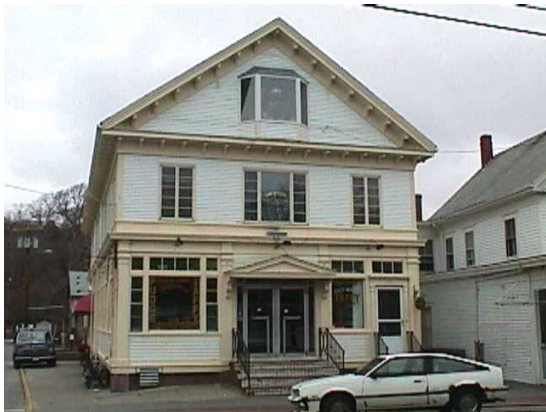
274-276 Commercial St. is a 2-1/2-story, 3-bay, Queen Anne-style mixed-use commercial/residential building; gable-front roof is sheathed in asphalt shingles, full cornice return with brackets; exterior is clad in clapboard siding with wood corner boards and trim; building sits on a brick foundation; fenestration includes Queen Anne display windows; 1/1 replacement DHS, 2/2 DHS, 2/1 DHS replacements, 2nd story contains paired 5-light casements and a central single-light window; modern attic bay window; primary entrance is accessed by modern centered paired doors with brick stoop and metal railing, door is sheltered by a pedimented hood with end brackets; 1st story storefront cornice; pilasters separate each bay on 1st story; secondary entry on front façade contains modern doors, 3-light transom, concrete stoop and metal railings; roof deck; rear façade contains cornice, pilasters, central entry with entablature, concrete steps, another entry located to side with porch deck.
