MASSACHUSETTS HISTORICAL COMMISSION FORM B - BUILDING

Town Provincetown
Place *(neighborhood or village)*
Address 337-345 COMMERCIAL ST
Building ID 997
Parcel No. (PID) 12-1-012-0
Mapbase # 12-1-012
Building Area 5962.852
Historic Name
Present Use Commercial
Original Use Commercial
Date of Construction 1858
Source maps and atlases
Style/Form Colonial Revival, Vernacular
Architect/Builder
Exterior Material asbestos, brick facing
Foundation obscured
Wall/Trim wood
Roof cross gable
Outbuildings/Secondary Structures

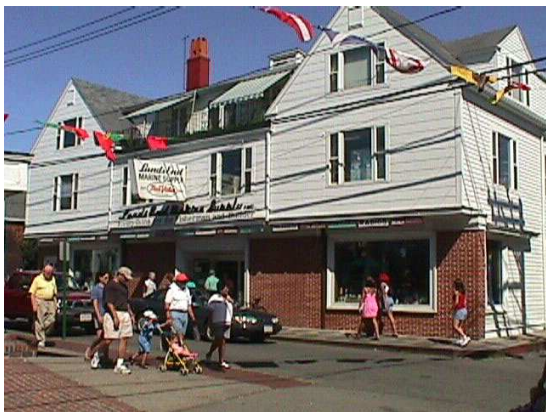
Photograph

337-345 Commercial St. is a 2-1/2-story, 4-bay, vernacular Colonial Revival-style commercial building; cross-gable roof is sheathed in asphalt shingles, interior brick chimney with a terra cotta cap; exterior is clad in asbestos shingles with brick facing on 1st story of front façade and wood shingles on secondary façade; building sits on an obscured foundation; fenestration includes aluminum Chicago-style picture windows, 1st-story bay windows with hipped metal roof and single-pane vinyl windows; recessed main entrance contains clapboard siding within that appears to have filled a larger entrance; 2nd story slightly overhangs 1st story; the roof has cross gables at each end on the primary façade and a shed dormer between the gables containing modern paired French doors, modern paired multi-pane casement windows and an iron balustrade across porch; two buildings on lot now connected by new addition that is clad in vinyl and contains all vinyl windows.
