MASSACHUSETTS HISTORICAL COMMISSION FORM B - BUILDING

Town Provincetown
Place (neighborhood or village)
Address 129 BRADFORD ST
Building ID 174
Parcel No. (PID) 12-1-025-0
Mapbase # 12-1-025
Building Area 1277.052
Historic Name
Present Use Commercial/Residential
Original Use Residential
Date of Construction 1840-1860
Source NR Nomination
Style/Form Greek Revival
Architect/Builder
Exterior Material clapboard
Foundation brick
Wall/Trim wood
Roof Front gable
Outbuildings/Secondary Structures

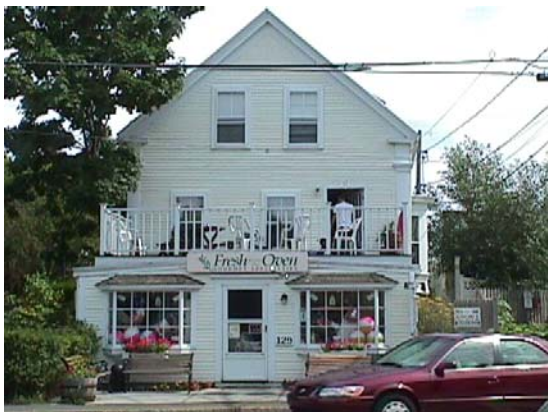
129 Bradford Street is a 2 1/2-story, 3-bay, Greek Revival-style, former sidehall cottage; the front-gable roof is clad in asphalt shingles, pedimented gable dormers exist on the east and west facades and the brick interior chimney is located at the peak; the exterior is clad in clapboard siding, details include corner pilasters and partial cornice returns and the foundation is brick; the fenestration includes 2/2 wood DHS with wood trim, a bay window is located on the side façade at the 2nd story level and bay windows on the 1-story, gable front addition have 12-pane wood casements flanked by 3-pane wood casement windows, with a hipped roof covered in wood shingles; A 1-story commercial addition is located on the front of the building and contains a central entry, flanked by multi-light, fixed pane bay windows; A deck has been built on the roof of this addition and has square balusters and a multi-pane wood door.
