MASSACHUSETTS HISTORICAL COMMISSION FORM B - BUILDING

Town Provincetown
Place (neighborhood or village)
Address 389-393 COMMERCIAL ST
Building ID 1168
Parcel No. (PID) 12-2-014-0
Mapbase # 12-2-014
Building Area 2481.944
Historic Name
Present Use Commercial
Original Use Commercial
Date of Construction 1850
Source NR Nomination
Style/Form Greek Revival, Vernacular
Architect/Builder
Exterior Material Clapboard
Foundation brick
Wall/Trim wood
Roof Front gable
Outbuildings/Secondary Structures

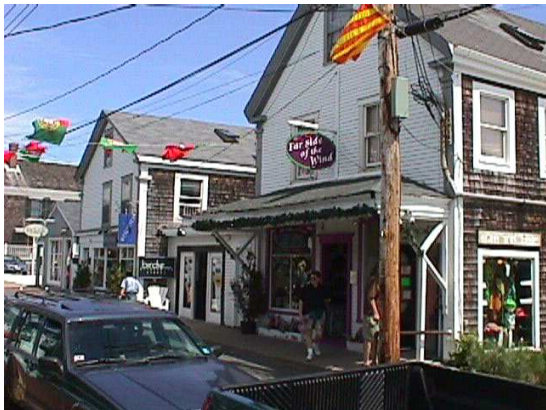
389-393 Commercial St. is a pair of 2-1/2-story, 3-bay, vernacular Greek Revival-style commercial buildings connected by a small modern 1-story connecting building; the gable-front roofs are sheathed in asphalt shingles, partial cornice returns, modern skylights, exterior brick and concrete block chimneys; the exteriors are clad in clapboard siding on the front facades and wood shingles on the secondary facades with wood corner pilasters and trim; fenestration includes 1/1 vinyl DHS, 2/2 wood DHS, fixed storefront windows; both buildings are accessed by a central storefront entrance; one storefront is sheltered by a full-width hipped hood supported by oversize knee braces. The 1-story center connecting structure has a side-gable roof sheathed in asphalt shingles, and is accessed by two large-pane replacement doors.
