MASSACHUSETTS HISTORICAL COMMISSION FORM B - BUILDING

Town Provincetown
Place (neighborhood or village)
Address 519 COMMERCIAL ST
Building ID 1030
Parcel No. (PID) 15-1-014-0
Mapbase # 15-1-014
Building Area 1365.98
Historic Name St. Mary of the Harbor Epis Church
Present Use religious
Original Use
Date of Construction 1880
Source Tax assessment
Style/Form Colonial Revival, Vernacular
Architect/Builder
Exterior Material Wood shingle
Foundation brick
Wall/Trim wood
Roof Side gable
Outbuildings/Secondary Structures

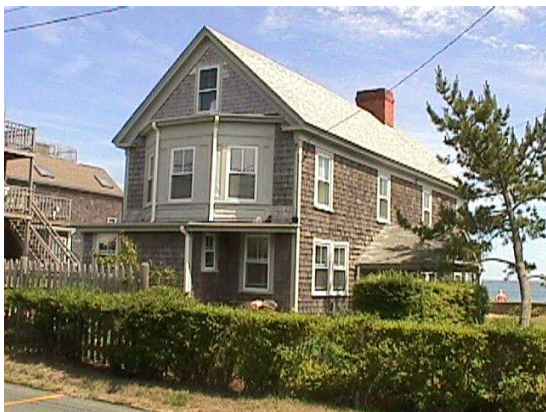
Photograph

The second building at 519 Commercial St. is a 2-story, 4-bay religious building; side-gable roof is sheathed in asphalt shingles; partial cornice returns; corbelled brick chimney; exterior is clad in wood shingles with wood corner boards and trim; fenestration includes single and paired 2/1 vinyl DHS windows with snap-in muntins, 2nd-story bow window on gable end is clad in pressed metal; entrance is accessed by a replacement pane-and-panel door; entrance is sheltered by a 1-story gable-front porch supported by square posts with brackets; 1-story open porch on south facade; 1-story shed addition to south side with concrete block chimney.
