MASSACHUSETTS HISTORICAL COMMISSION FORM B - BUILDING

Town Provincetown
Place *(neighborhood or village)*
Address 240 1/2 BRADFORD ST
Building ID 694
Parcel No. (PID) 15-2-024-0
Mapbase # 15-2-024
Building Area 808.164
Historic Name
Present Use Residential
Original Use Residential
Date of Construction 1941
Source Tax assessment
Style/Form Colonial Revival
Architect/Builder
Exterior Material wood shingle
Foundation concrete block
Wall/Trim wood
Roof Side gable
Outbuildings/Secondary Structures

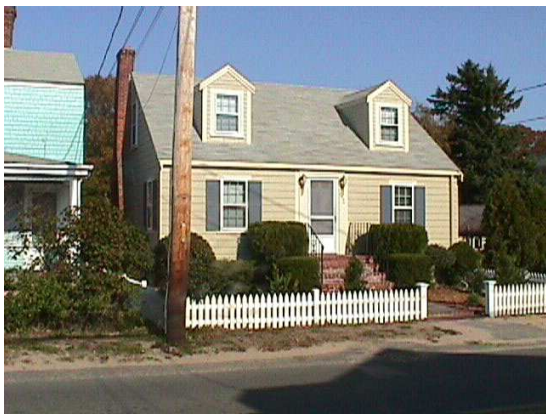
Also known as 240 1/2 Bradford Street, this is a 1 1/2-story, 3-bay Colonial Revival Cape Cod dwelling; the roof is side gable, there are 2 gable dormers in the front roof slope, a shed roof wall dormer is located on the rear and an exterior brick chimney is located on the side of the building; the exterior is clad in wood shingles and the foundation is concrete block; fenestration includes 6/6 vinyl DHS with snap-in muntins and inoperable shutters and 6/6 wood DHS on the side facade; the primary entrance is centered on the facade and accessed by brick steps with iron railings, a secondary entrance on the east facade consists of a 1-story, side-gable vestibule that is reached by concrete block and brick steps; a deck is located on the 1st floor of this facade.
